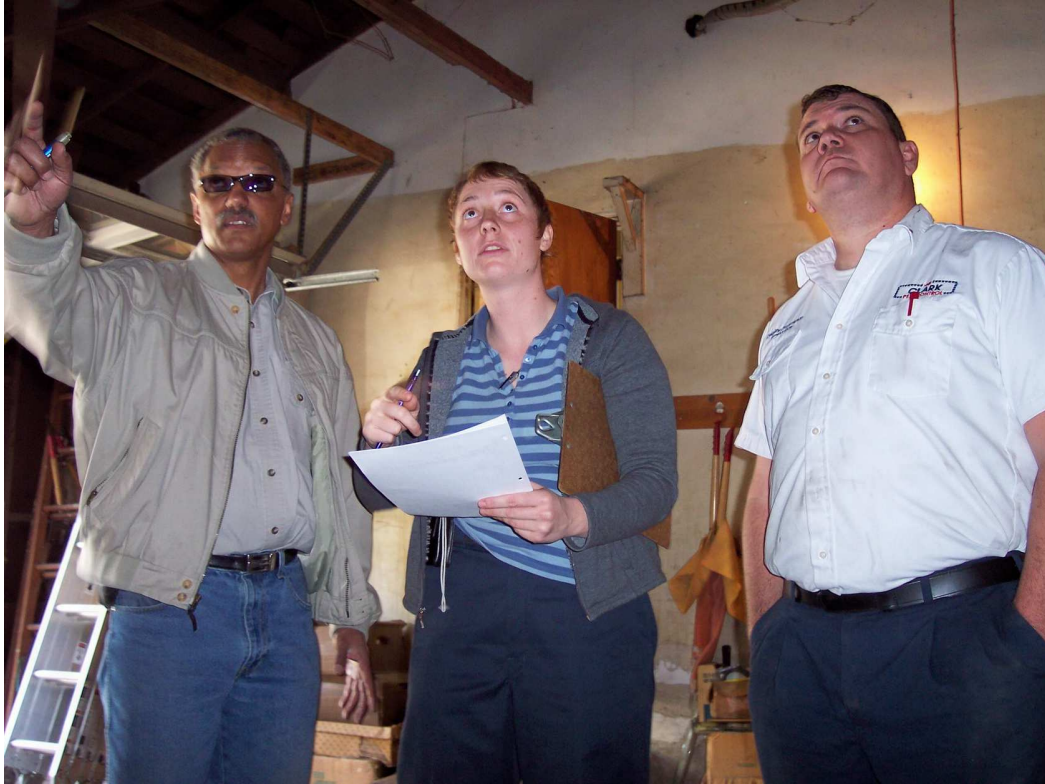
Figure 1. Example of UCB and Clark Pest Control research team examining a potential candidate home for the study; location Santa Ana, CA. Included in the image from left to right are V. Lewis and S. Moore, UC Berkeley and M. Red, cooperating PMP.

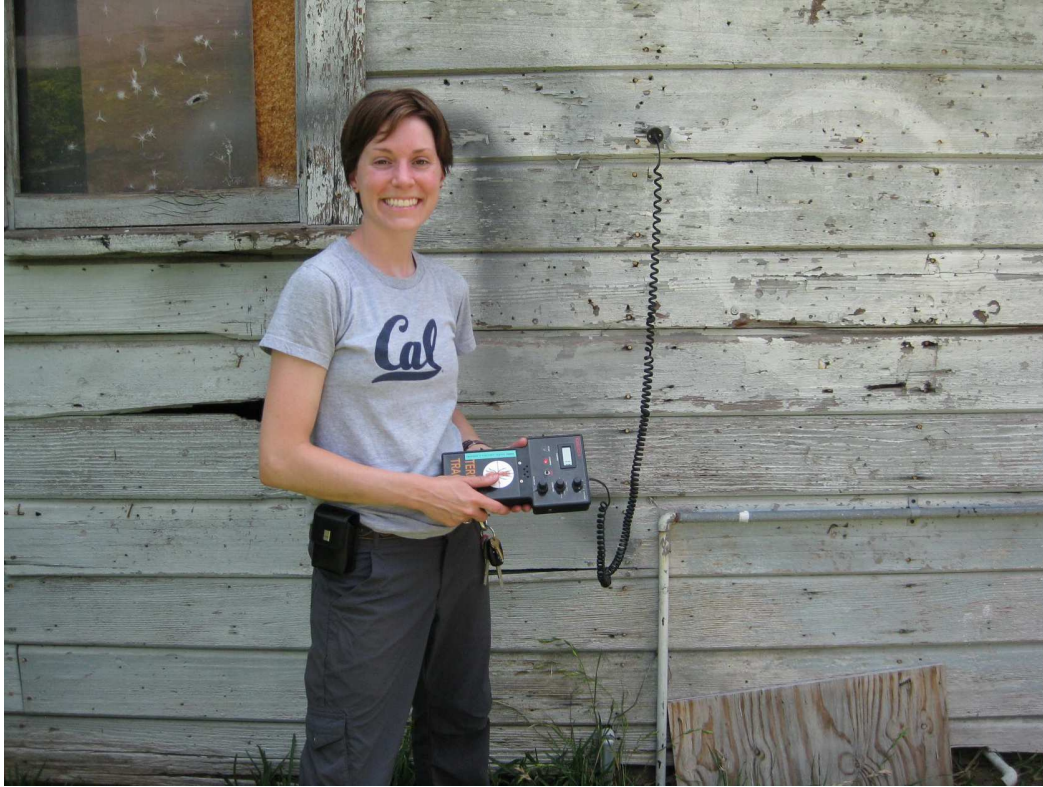
Figure 2. AE monitoring of board for drywood termite activity in Glendora, CA. Include in image is R. Tabuchi, UC Berkeley.

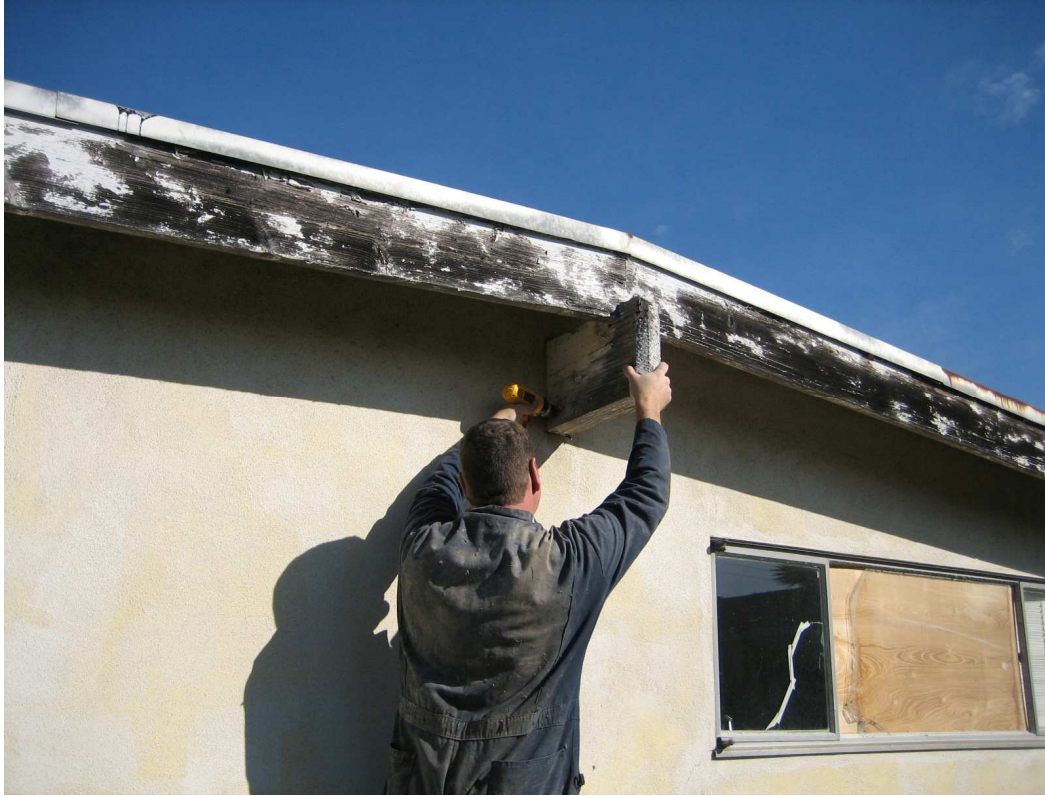
Figure 3. Example of drilling a board infested with drywood termites before Treatment; location Torrance, CA. Included in image is M. Red, Clark Pest Control.

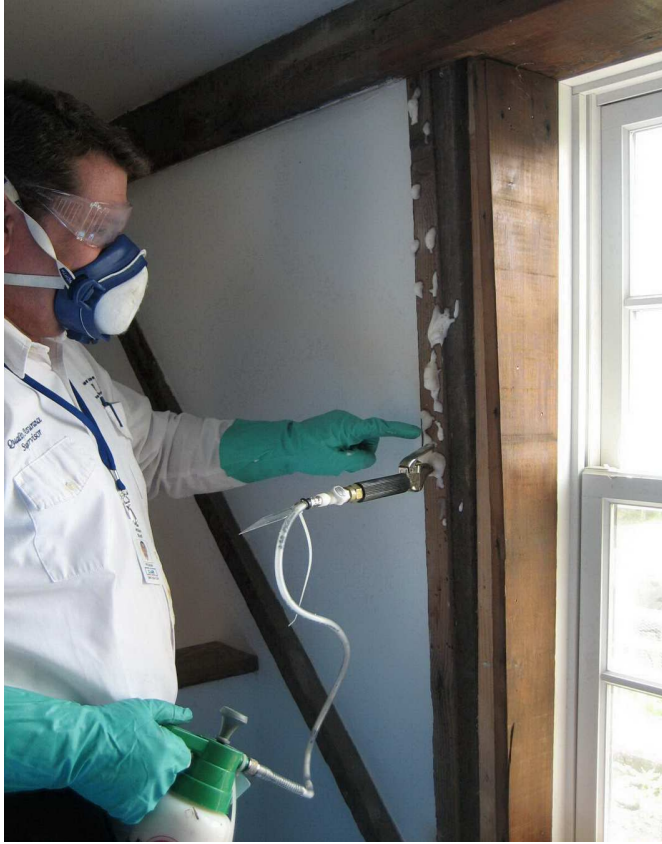
Figure 4. Example of injecting Optigard into infested board; location Petaluma, CA. Included in image is M. Red, Clark Pest Control.

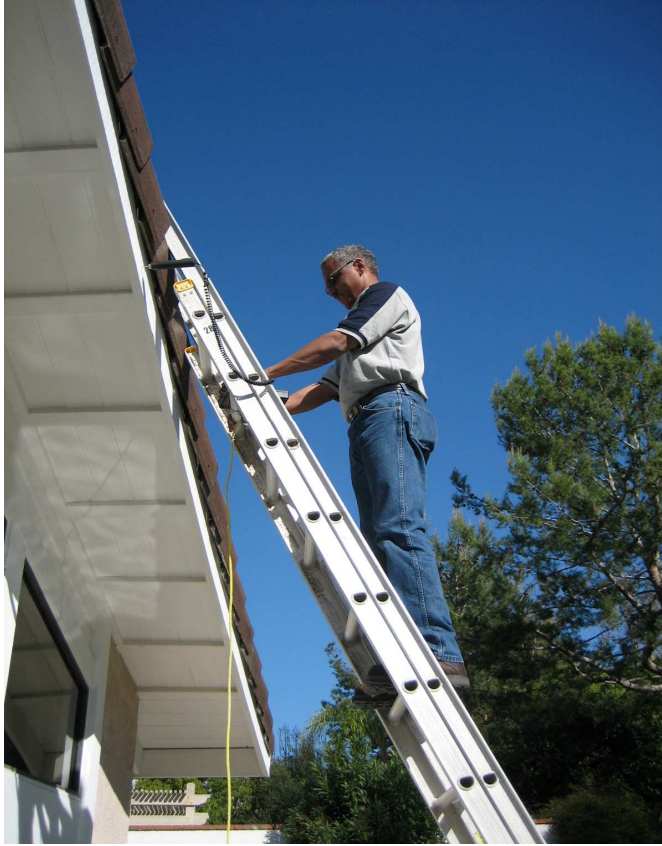
Figure 5. A high-degree of difficulty local-treatment; inspection and treatment conducted in Lake Forest, CA. Included in image is V. Lewis, UC Berkeley.
